IMPACT OF URBANISATION ON WATERBODIES - CHENNAI

Abstract - Chennai, the capital city of Tamil Nadu, has witnessed very fast urbanization because of the attractive employment opportunities available. During the last two decades Velachery, the Southern part of Chennai has witnessed rapid growth and hence a land use pattern change. Sometimes the growth is not in accordance with the Chennai Metropolitan Development Authority's, Development Control Rules. Encroachment both public and private in the water bodies and water courses also adds on to this problem. So the study area is severely affected by flood even during less precipitation, which causes inundation of the area. The flood discharge from the Velachery area has to drain into the Pallikaranai swamp, which is receiving the discharges from a larger area comprising of 96 tanks. Due to heavy inflow into the swamp during floods the swamp swells causing afflux so that the discharge from the study area is not able to readily enter into the swamp and causing flood. This study has been aimed to bring the impact of urbanisation in the study area by analysing both quantity and quality of water. Using Geographical Information System (GIS)

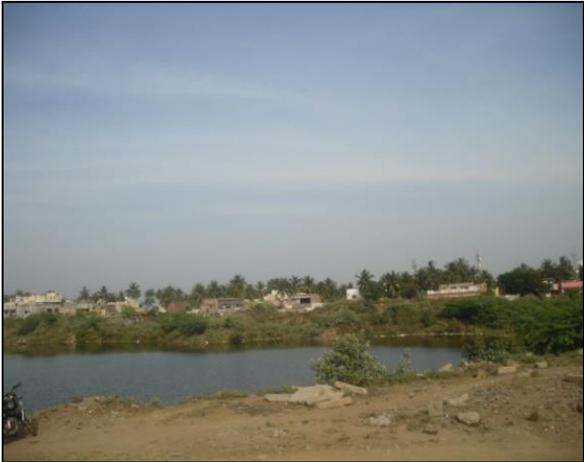
Fig 5 : Current Status of Adambakkam Tank

The Fig 5 and 6 show the current status of Adambakkam tank and Velachery tank, where in the encroachment and pollution have been explicitly shown.

Based on the quantity analysis of the tanks it has been clearly indicates that only Adambakkam tank has 10% of water storage capacity and Velachery tank has 30 to 40% of storage capacity. Remaining all the tanks which is pertinent to study area have completely urbanized. After the quantity analysis the quality analysis was carried on Post-monsoon and Pre-monsoon.

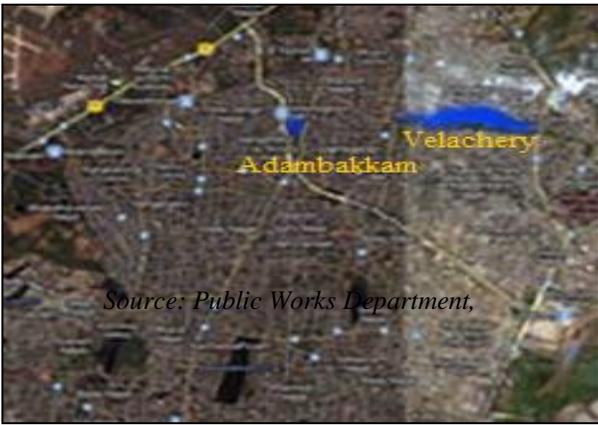
1948 Source: Google image, 2012
 Fig 4 : Tanks in Present Condition

Fig 4 shows the present status of the tanks in the study area, which was taken from the Google image. From the toposheet the tanks which was in study area has been identified and the original capacity of the tanks has been given from the memoirs. Then using GIS the current status of the tanks has been delineated. The Figure 1.4 clearly shows that the tanks Ullagam, Nanganallur, Palavan Tangal and Talaikananchery were completely defunct condition because of urbanisation. Though there is a provision to evict the encroached people the Government failed in this effort. Because of this reason the Velachery area has been frequently affecting flood during rainy season even though there was low intensity of rainfall.
